Budapest Neutron Centre ...for research, science and innovation!

# Industrial topics

## The real operational conditions of helicopter rotor blades applying Non-Destructive Testing technologies

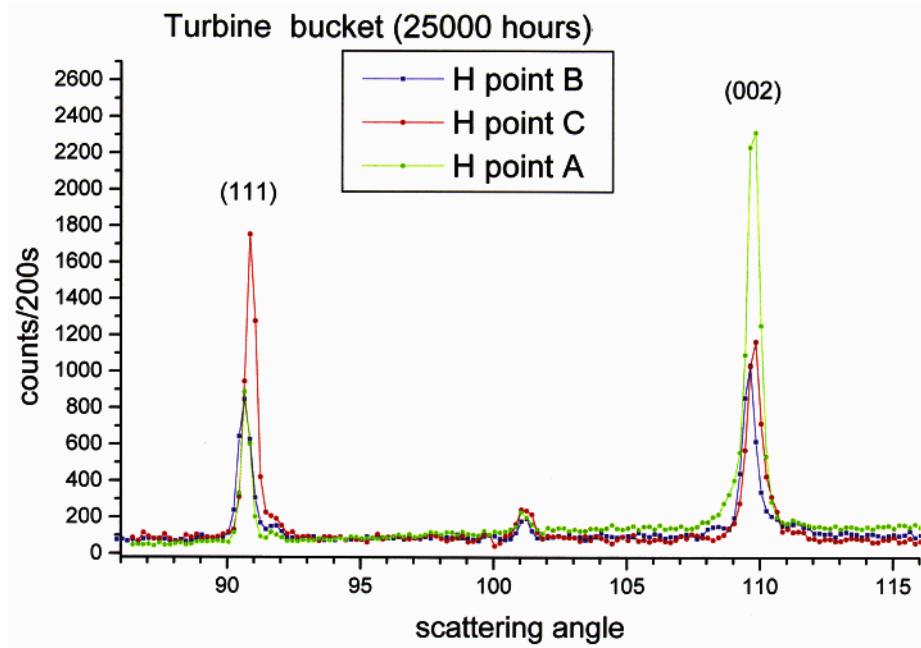
The obtained spectra showed that during the operation the crystallinity is growing: near the Ni peaks the satellites indicated phase decompositions, this effect depending on temperature and RS. These satellites appeared much lower in the new bucket. This study allowed monitoring the buckets ageing.

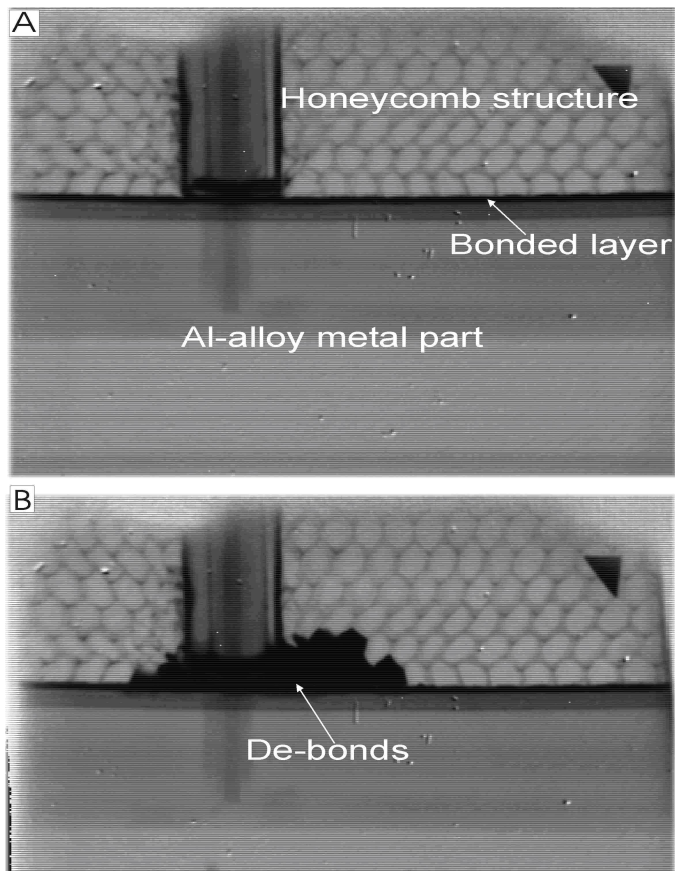
*Fig. 3. The bonds and de-bonds as detected by NR*

The most important bond is the one that sticks together the aluminum alloy metal main holder and the honeycomb structure. Figure 3/a show this part. The bonded area is seen as a horizontal black line under dry condition. In the Fig. 3/b the efficacy of moistening in unveiling the damage of the gum sealing at the border of the sections by centrifugal force was explicitly demonstrated.

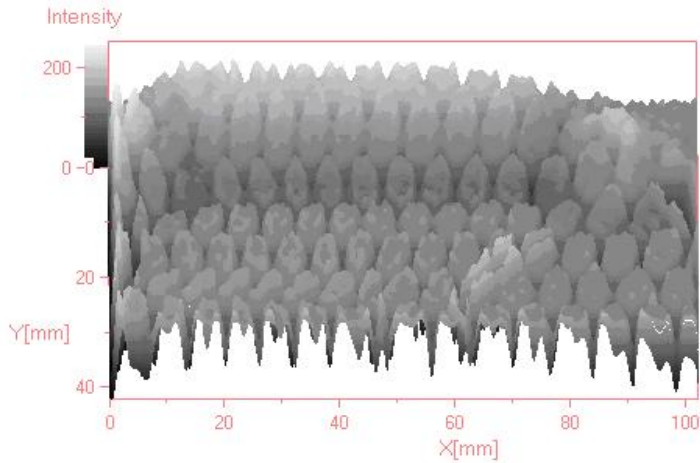
Fig. 4. 3D intensity histogram of an NR image displaying the a delamination

The other failure makes up the delamination within piles of a laminate as displayed in Fig. 4., which is a 3D histogram representation of the honeycomb structure revealed by NR. The Figure 5 shows Sobel-enhanced edges of the delamination. A such disclosed were ('A'), porosity ('B'), and damage of the gum sealing ('C').

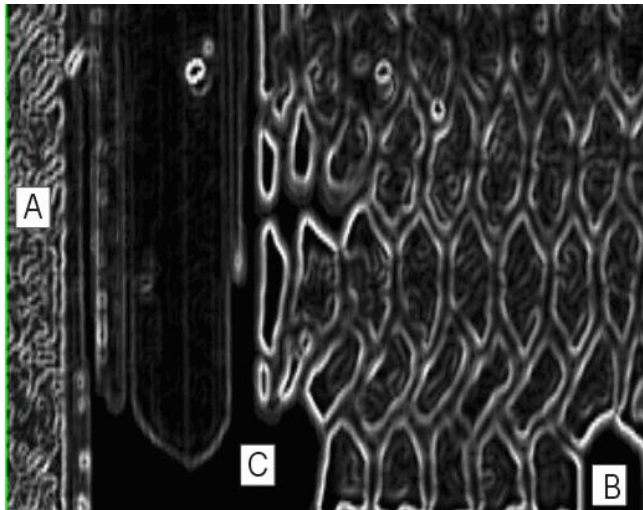
Fig. 5. Analysed DNR image, demonstration various defects: 'A' honeycomb misalignment; 'B' porosity; 'C' damage of gum sealing.

Honeycomb misalignment is distortion of the piles resulting in changes from the desired orientation. These defects are due to improper lay-up and cure. Porosity ('B') is pockets within the bonding material. They are begot by entrapped air and gas bubbles, and caused by volatile substances, improper flow of resin and unequal pressure distribution. De-bonds ('C') were discussed above.

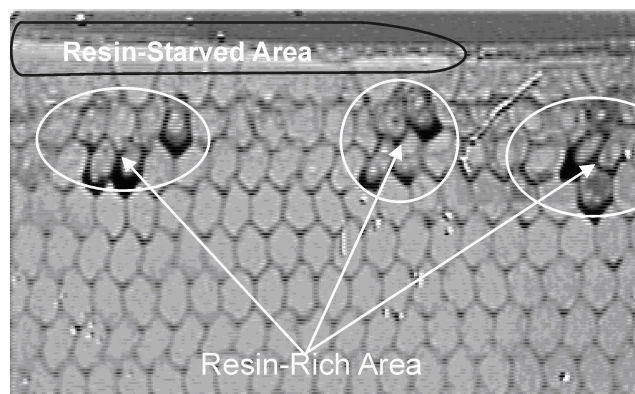
Fig. 6. Resin-rich area and resin-starved areas as revealed by DNR imaging

The DNR image exhibited in Figure 6 discloses another type of defect, i. e. resin-rich areas and resin-starved ones. Resin rich areas are localized, and filled with resin or lacking in fiber. The defect is caused by improper compaction or bleeding. Resin-starved areas are localized with insufficient resin evident as dry spots.

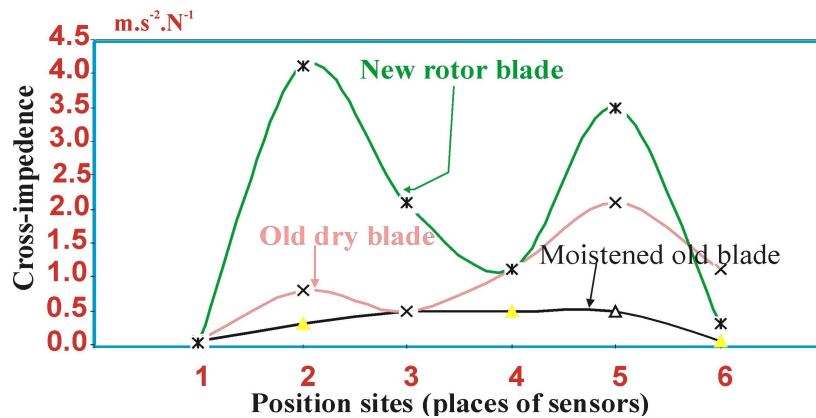
Fig. 8. The stored vibration energy of an old and a new rotor blades at a frequency band of 2.5-3 kHz

The Figure 8. demonstrates distinct differences in the vibration energy collector capacity between new and old rotor blades in dry and moistened conditions. At a frequency band of 2.5-3 kHz exciting energy, the energy storage for the either the new or the old one displayed two peaks. The damping capacity for the new one was considerably lower than that for the old one. While the moistened blade exhibits no peak vs. the sensors positions. Another important observation from the SEA model that with increasing the frequency of exciting energy the energy storage capacity of the new blade's the first position, i. e. the blade end, was considerably, about 2 order, higher. It underlines the significantly less damping property of that section of the new rotor blade. These evidences clearly prove that applying the two subsystems SEA models into the blade adequately indicates the differences in the conditions of the blades. According to the SEA measurement no damage to the blade was caused either by neutron or X-ray radiation during the test.
