Budapest Neutron Centre ...for research, science and innovation!

# Industrial topics

## The real operational conditions of helicopter rotor blades applying Non-Destructive Testing technologies

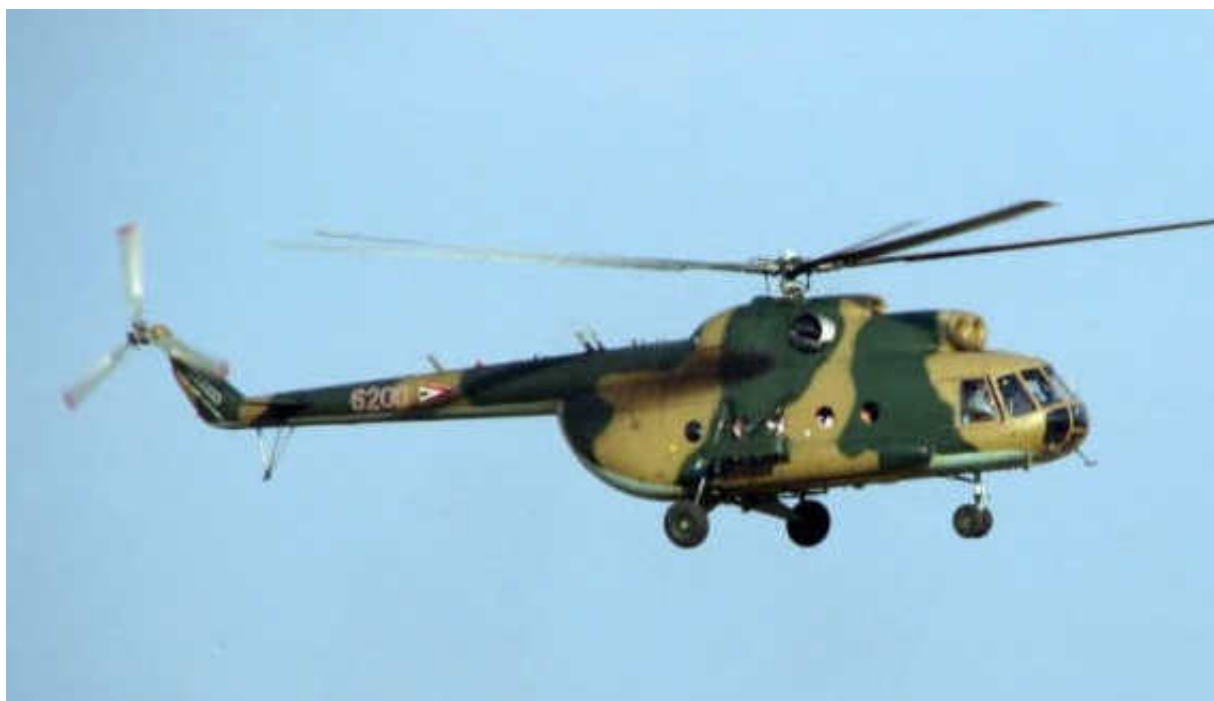
*Fig. 1. One of the investigated objects*

capable of investigating the irregularities in the fiber-glass/epoxy honeycomb structures. The details of metal parts and contactor of the heating elements are shown by DXR. The Statistical Energy Analysis (SEA) and other Vibration Diagnostic (VD) methods are suitable for identifying small changes of structural damping. The *ut supra* mentioned measurements can be performed at the Dynamic Radiography Station (DRS) of the Budapest reactor where the necessary development, regarding the extension of the dimensions of the investigated object, has been carried out. As a result the working place can inspect 10 m long and 0.7 m wide targets by neutron and X-ray radiography and by VD. The main goal of the present study was to demonstrate the applicability of the DRS technique in revealing the defects of the composite structures of helicopter rotor blades for the Hungarian Air Force (Fig. 1).

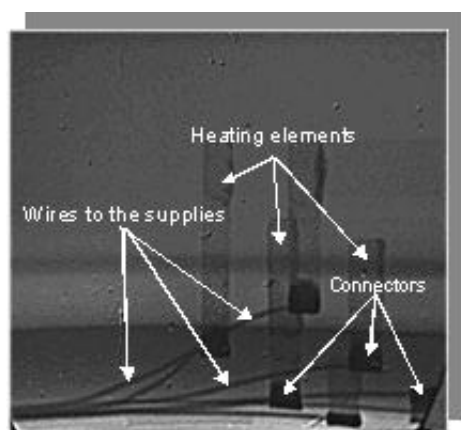
Fig. 7. Metal parts of the rotor blade visualized by XDR.

Figure 7 shows the heating element arrangements that serve as anti-ice heating in freezing conditions and their contacts to the supply cable.
